**Mattson  
Macdonald  
Young**  
structural  
engineers

14 September 2015

Project No.: 15538.00  
Re: Structural Condition Review of the building at 700 4<sup>th</sup> St. E.

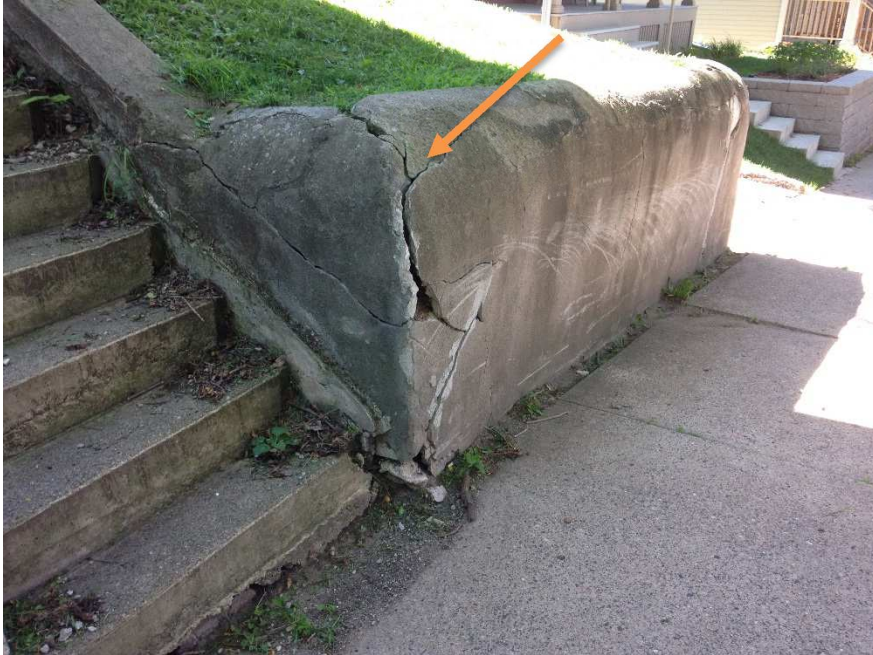
The retaining wall at the front of the house is cracking and needs to be replaced. Picture 1 shows an overall view of the front retaining wall. Picture 2 shows the portion of the retaining wall that is showing the most cracking. A portion of the retaining wall has tipped. As the retaining wall continues along the southern side of the building its deflection increases. Picture 3 shows the wall, as seen from 4<sup>th</sup> street. There are also cracks that appear to go through the wall. Picture 4 shows one such crack.

**Picture 2 – Front Retaining Wall**

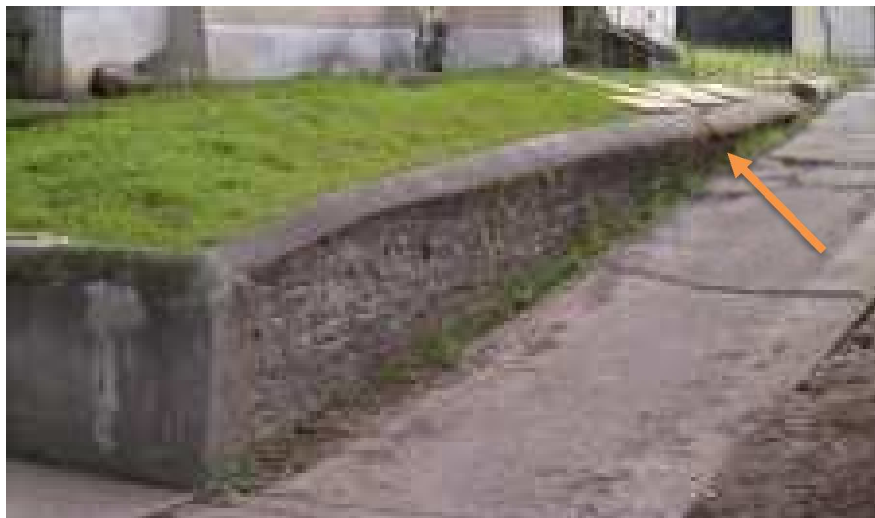
**Picture 3 – South Retaining Wall**

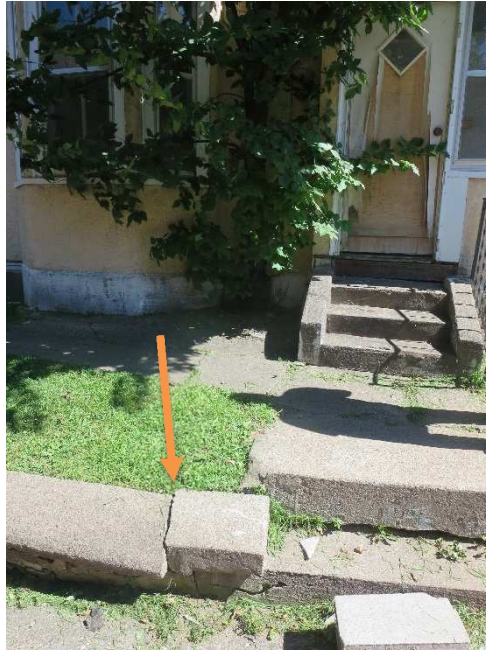
**Picture 4 – Crack at South Retaining Wall**

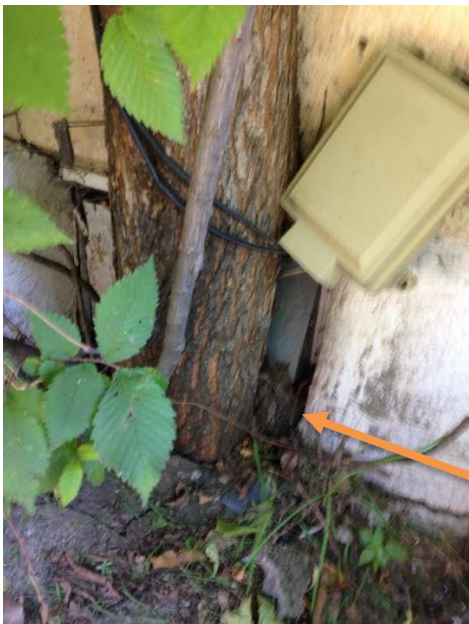
The bay along the south wall of the house appears to have settled. Picture 5 shows the bay and a crack that has occurred next to it. There is a tree that is growing just east of the bay. Its trunk is adjacent to the foundation wall. The tree is likely one cause of the settlement of the bay and could be the cause of other problems in the house. Picture 6 shows the base of the tree and the foundation wall. The background of Picture 4 shows the bay along with the tree as well.

**Picture 6 – Tree Growing Next to House**

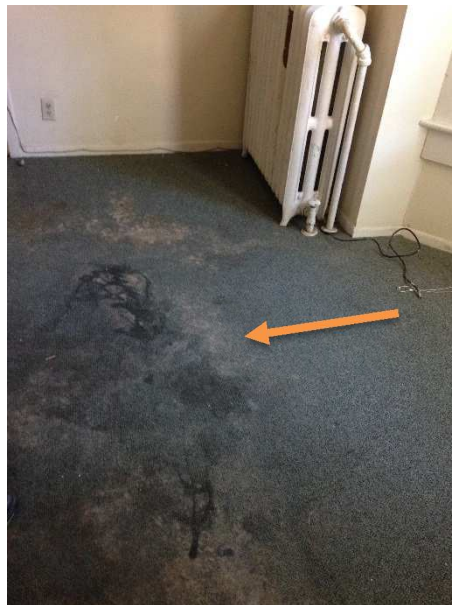
There is some water damage to the house. The eastern section of the south foundation wall showed signs of damage and rot. Picture 7 shows some of the rot that has occurred as well as spalling of the finish material along the foundation and bulging of the stucco on the wall. Water damage effects were found in the floor of the second story of the house. Picture 8 shows some of the damage. It is likely that there is damage that allows water to leak. The roof was observed from the outside to be sagging slightly (not pictured). It is likely that there is some damage to the roof, which is causing water to enter the house.

**Picture 8 – Water Damage in 2<sup>nd</sup> Floor**

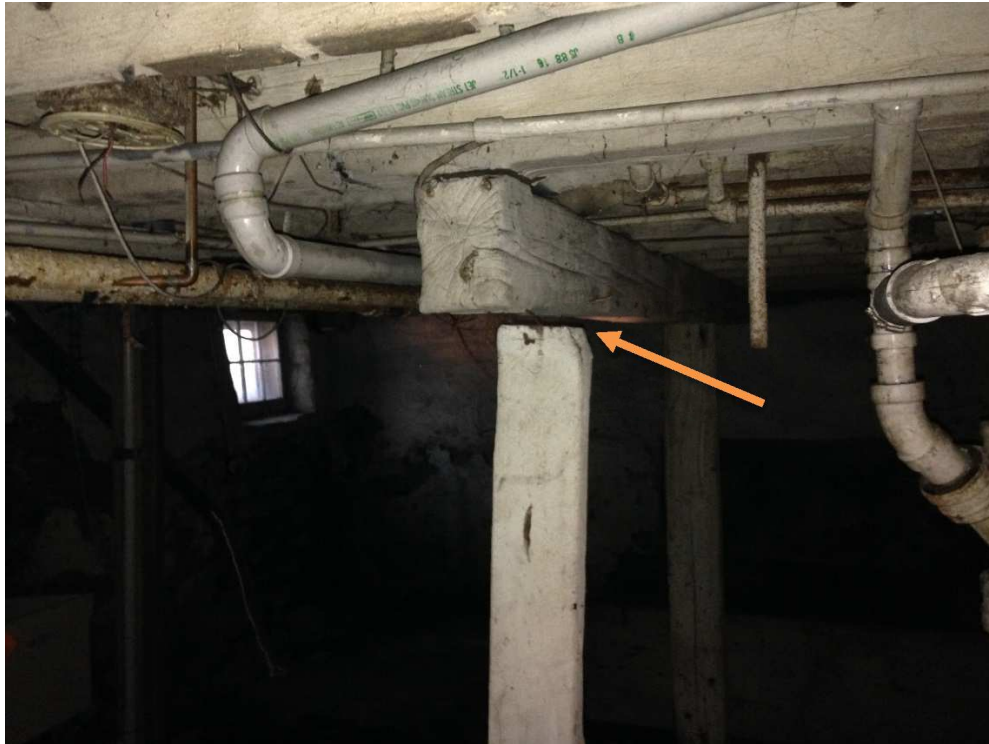
There are framing issues in the basement. There is a beam that does not rest on the column as it was originally designed. Picture 9 shows the beam as well as the column. The gap between the beam and the column is approximately 1 inch. The gap between the beam and column can be seen in the picture.

**Picture 9 – Beam Above Column in Basement**
